**G. GUNDAKER DAM
FRANKLIN COUNTY, MISSOURI
MO 30543**

PHASE 1 INSPECTION REPORT NATIONAL DAM SAFETY INSPECTION

G. GUNDAKER DAM
FRANKLIN COUNTY, MISSOURI
MISSOURI INVENTORY NO. 30543

PHASE I INSPECTION REPORT
NATIONAL DAM SAFETY PROGRAM
G. GUNDAKER DAM - ID No. 30543

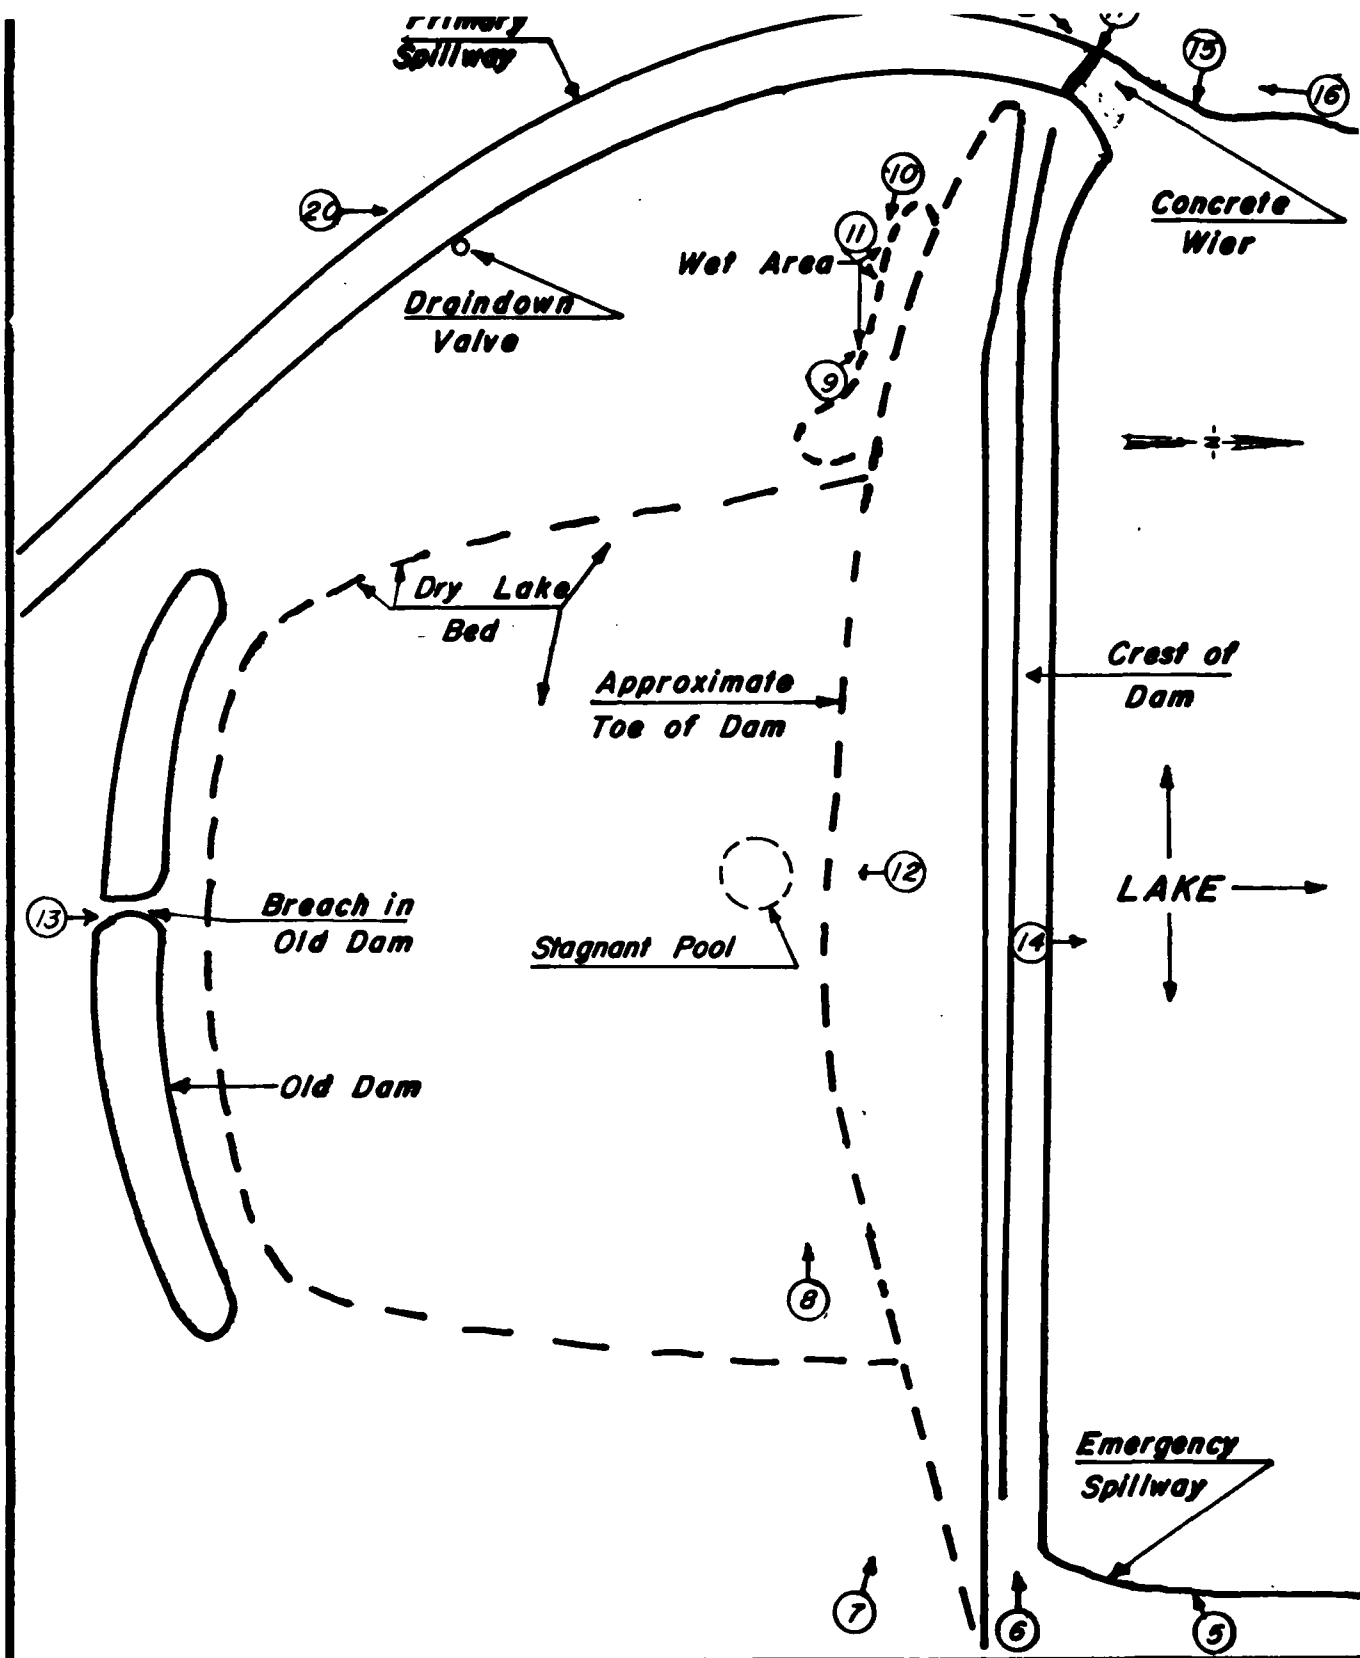
Plan Sketch
 Key To Photographs
 Sheet 2 Appendix D

There is an apparent area of seepage under the dam at the downstream contact on the west abutment side (see sheet 4 of Appendix A and photos 9, 10 and 11). The apparent seepage is manifested by wet, soft ground, cattails and small pools of rust-colored water. There is also a 30 ft diameter stagnant pool of water near the downstream toe at about the center of the dam. This appears to be near the area described as the starting point of the bored draindown pipe and could represent a depressed area due to sunken backfill or possible seepage under the dam along the pipe. The middle of the floodplain downstream (old pond area - probable location of original streambed) was wet and soft. A noticeable but small stream of water was flowing out of this area through the breach in the old dam below the main dam (see photos 12 and 13). To our knowledge, there had been no rain in recent days. The caretaker indicated there had been a 5 in. rain about three weeks before our site inspection.
